June 19, 2018

MH Ref: 8170089.01

Re: Building Envelope Condition Assessment
Graham-Terry Apartments, 2020 Terry Avenue, Seattle, WA

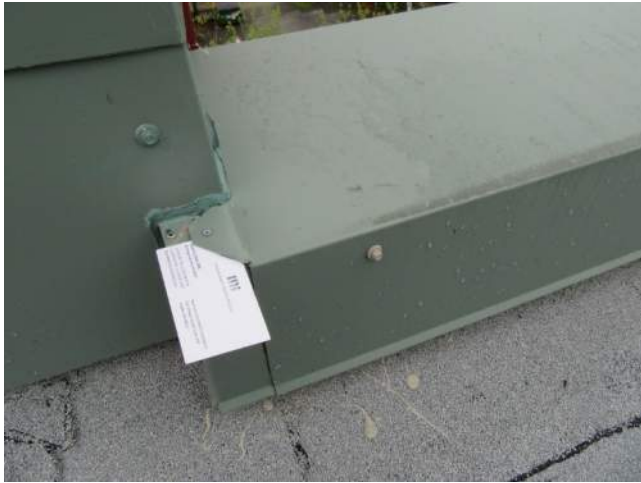
Photo No. A4.

Seams in parapet coping at location above north side of Unit 724 were not fully sealed.

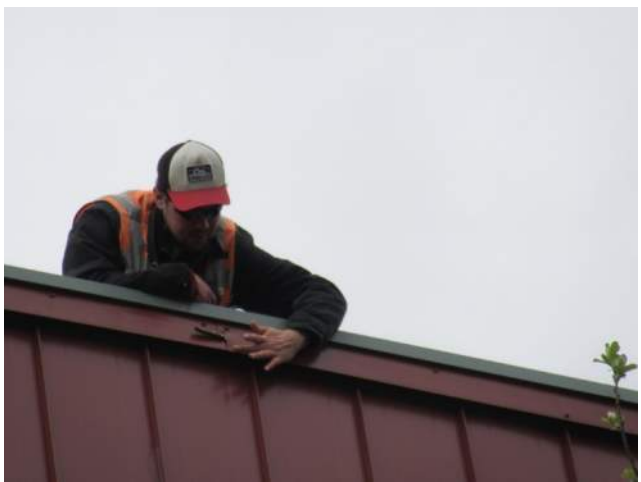
Photo No. A6.

Unsealed seam in transition flashing between roof parapet and top of sheet metal siding.

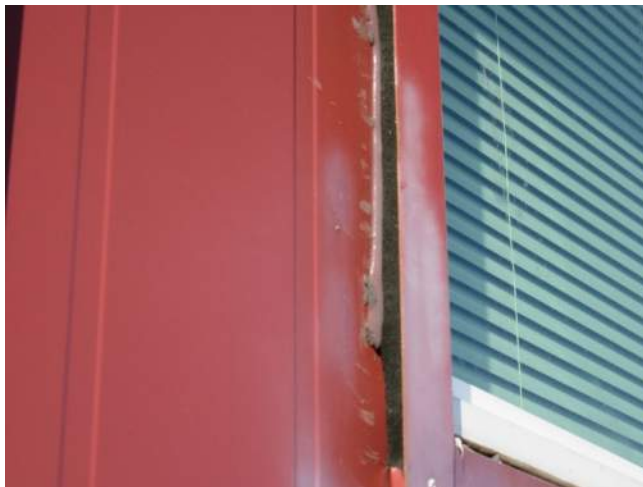
Photo No. A9.

Sealant not installed continuous behind foam closure gasket at window opening.

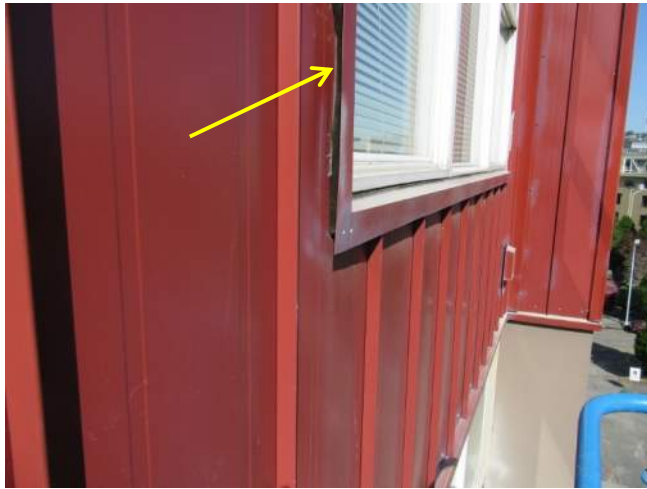
Photo No. A10.

Sealant not installed continuous behind foam closure gasket and foam closure deformed (arrow) at window opening.

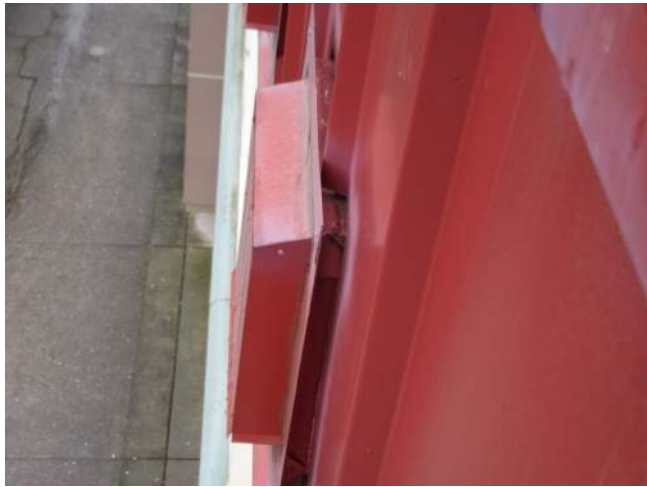
Photo No. A11.

Vent penetration cover not integrated into sheet metal siding system, as viewed from above.

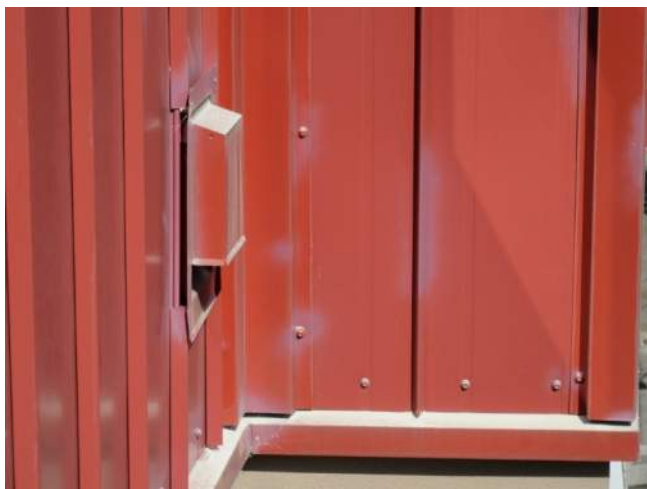
Photo No. A12.

Vent penetration cover not integrated into sheet metal siding system, as viewed from the side.

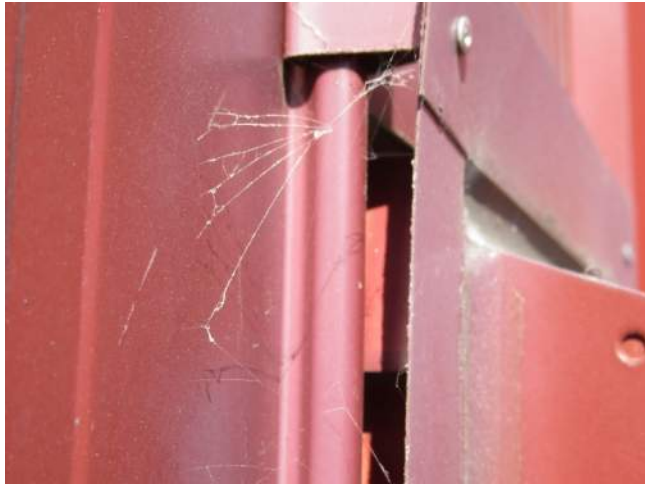
Photo No. A13.

Close-up view of upper side of vent penetration cover with no closure flashing.

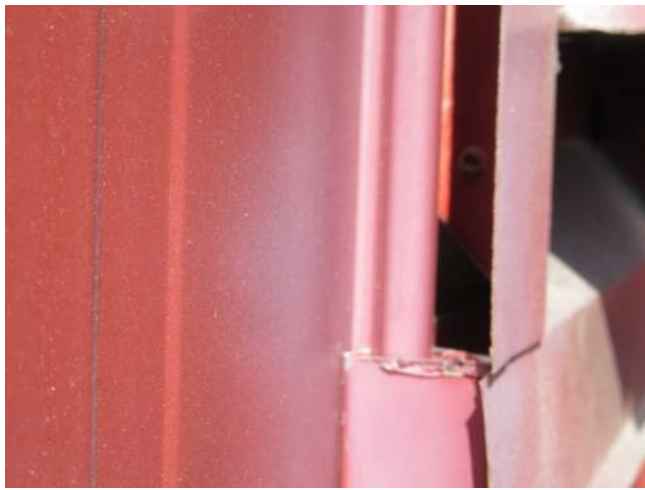
Photo No. A14.

Close-up view of lower side of vent penetration cover with no closure flashing.

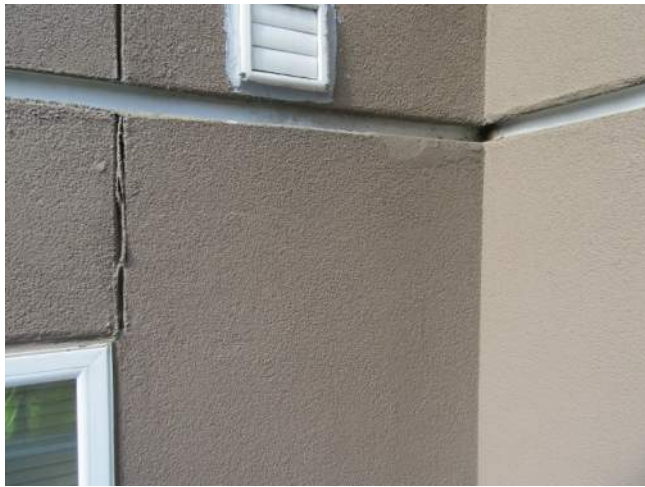
Photo No. A22.

Crushed or deformed vertical control joint above window jamb/head juncture.

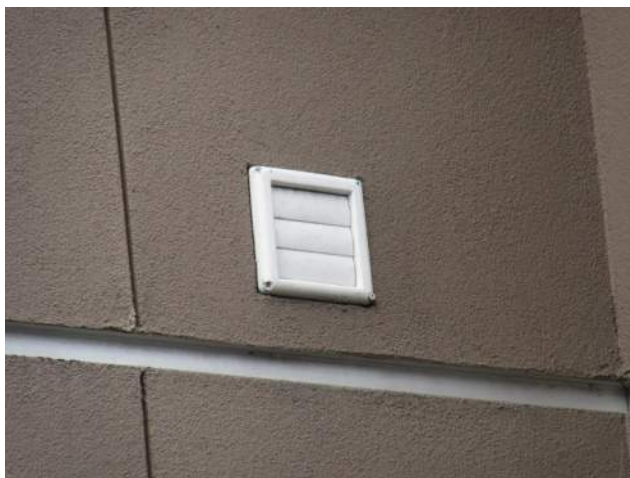
Photo No. A24.

Typical exhaust vent penetration with no sealant at perimeter of penetration (in 2017).

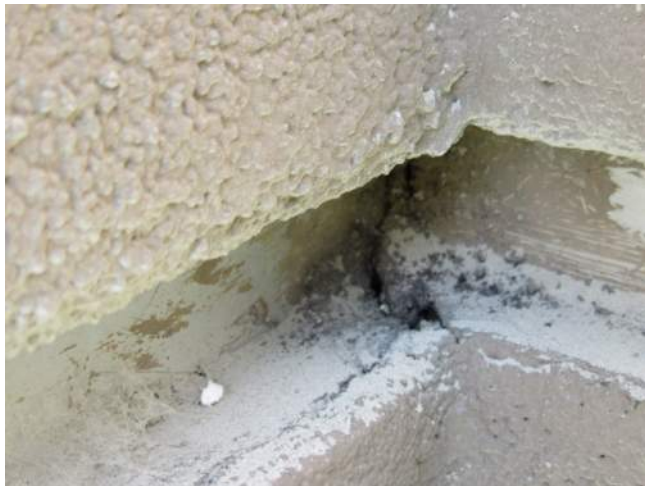
Photo No. A27.

Open hole at corner intersection of sheet metal reveal (Level 5).

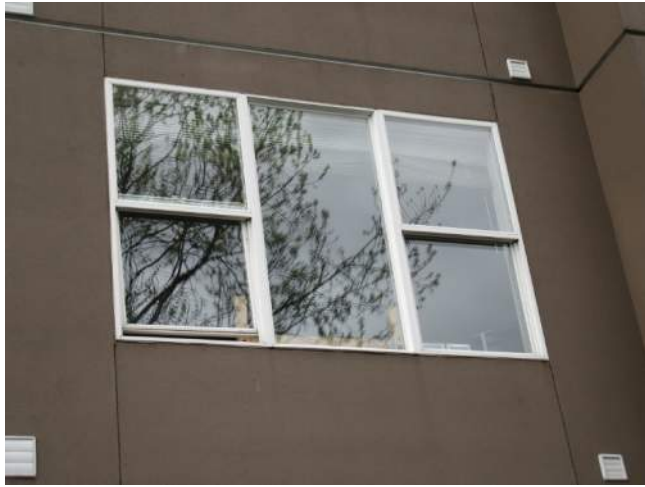
Photo No. A31.

The general condition of windows reviewed by MH at the 2020 Terry Building appears to be fair. A discussion with Brian Huff and a limited review the operation of the windows during the site visits indicate that many of the single-hung sash windows open and close with some difficulty and do not travel in alignment with the window frames (see Photos No. A31 through A34).

Skewed single-hung sash at Unit 424 (south side of window group).

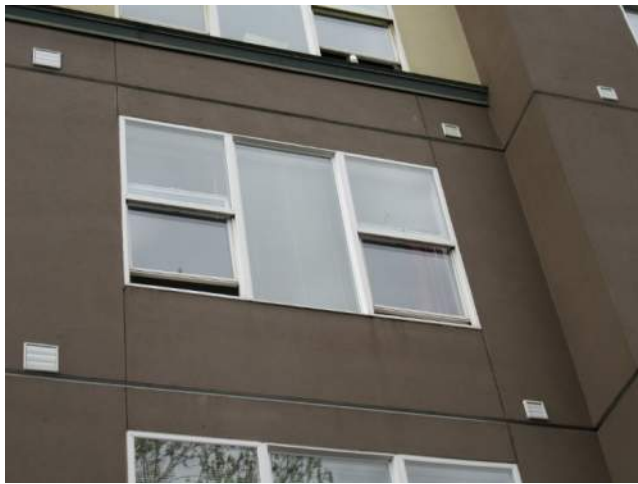
Photo No. A32.

Skewed single-hung sash at Unit 524 (south and north sides of window group).

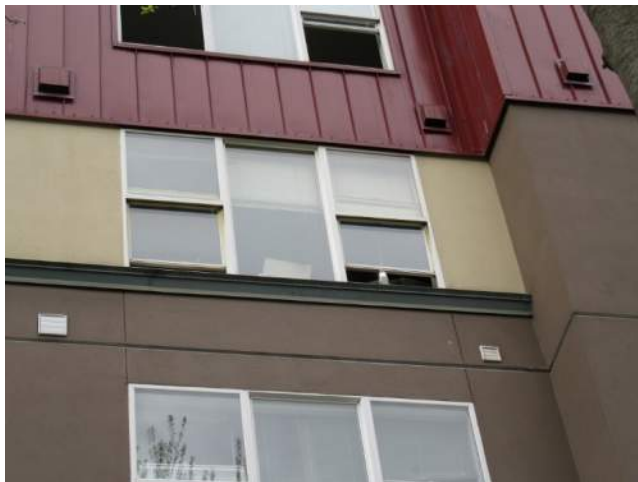
Photo No. A33.

Skewed single-hung sash at Unit 624 (north side of window group).

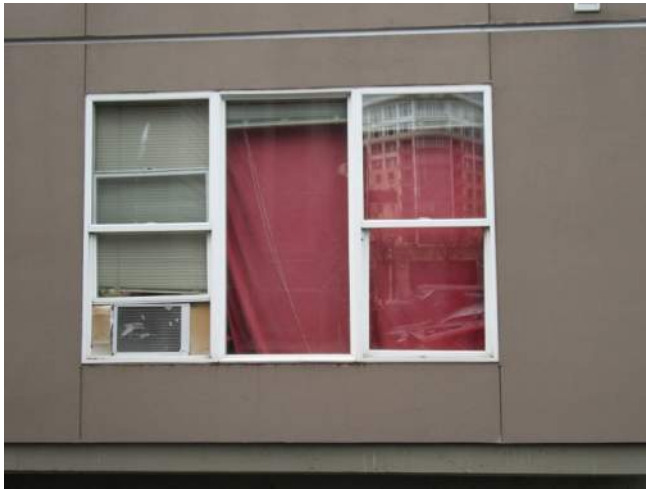
Photo No. A34.

Skewed single-hung sash at Unit 320 (south side of window group).

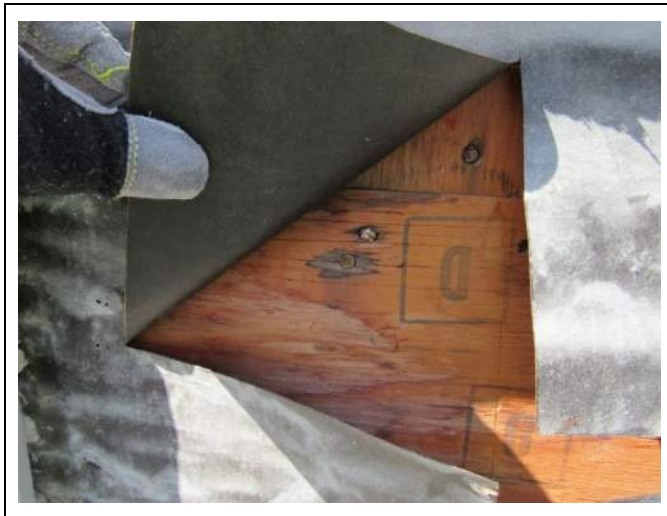
Photo No. B16.

Cluster of nails penetrating the asphaltic building paper at the side of the exploratory opening.

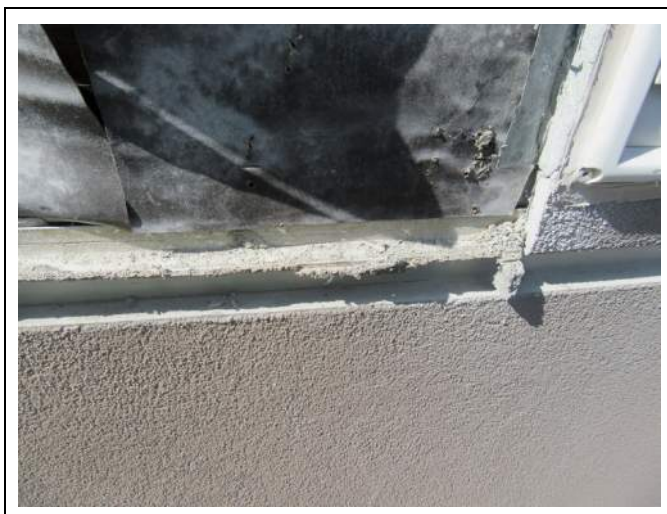
Photo No. B17.

Cluster of nails penetrating the asphaltic building paper at the side of the exploratory opening.

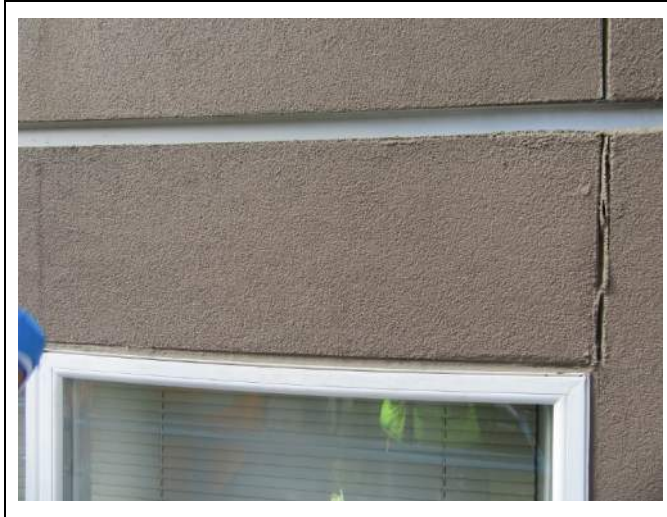
Photo No. 18.

Overall view of exploratory opening location with crushed or deformed control joint above window jamb/head juncture.

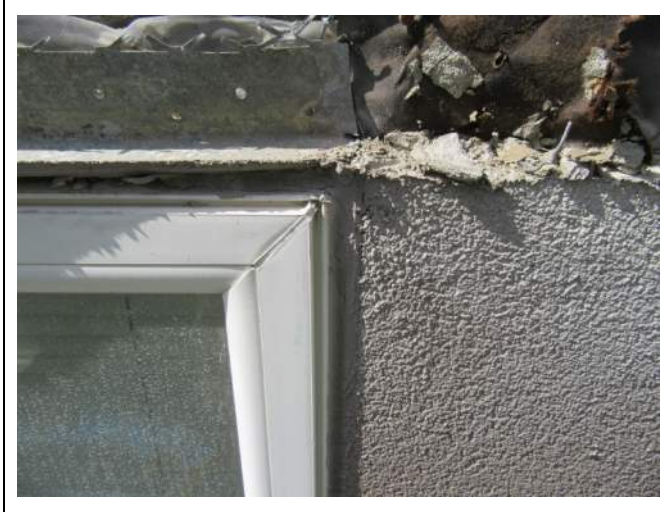
Photo No. B22.

Cluster of nails penetrating the asphaltic building paper at the right side of the exploratory opening.

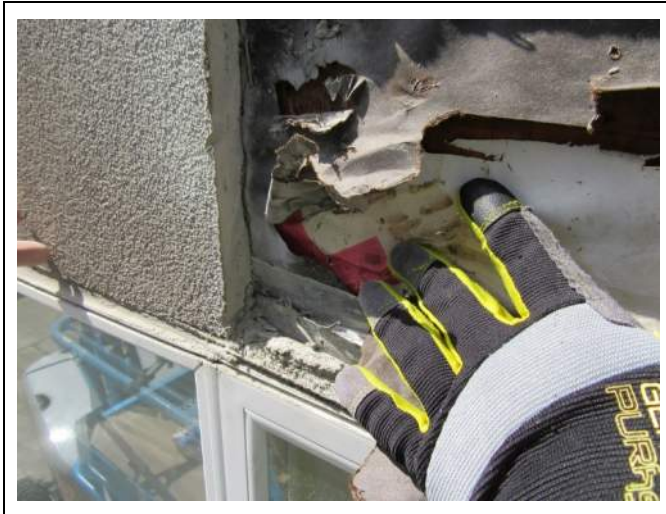
Photo No. B23.

Cluster of nails penetrating the asphaltic building paper at the right side of the exploratory opening.

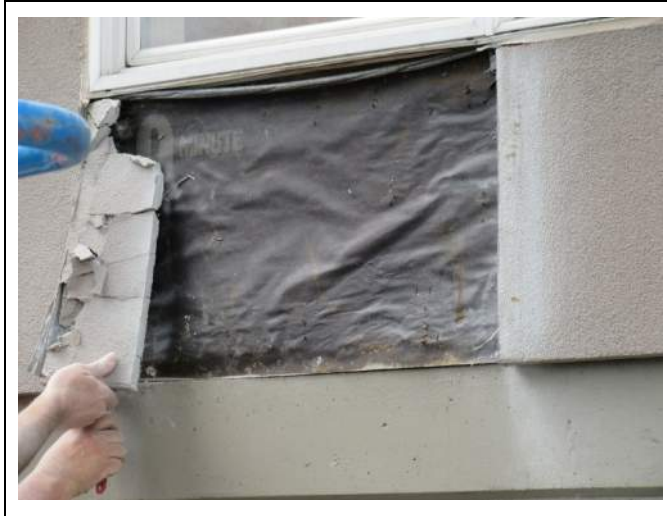
Photo No. B25.

Stucco cladding removed, showing asphaltic building paper with minor wrinkling.

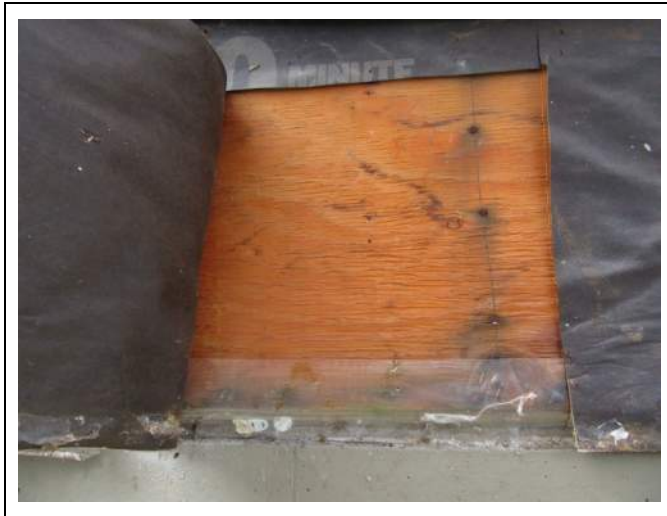
Photo No. B26.

View of exterior plywood sheathing with the asphaltic building paper peeled back.

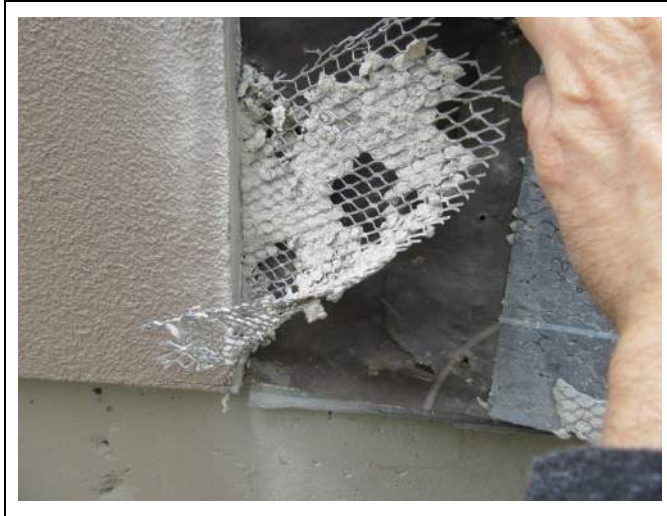
Photo No. B34.

Expanded metal lath of stucco cladding at exploratory opening.

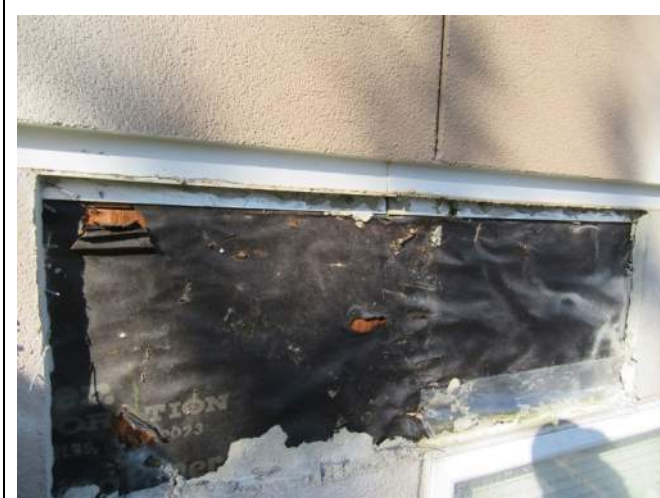
Photo No. B36.

Stucco cladding removed, showing asphaltic building paper with minor wrinkling.

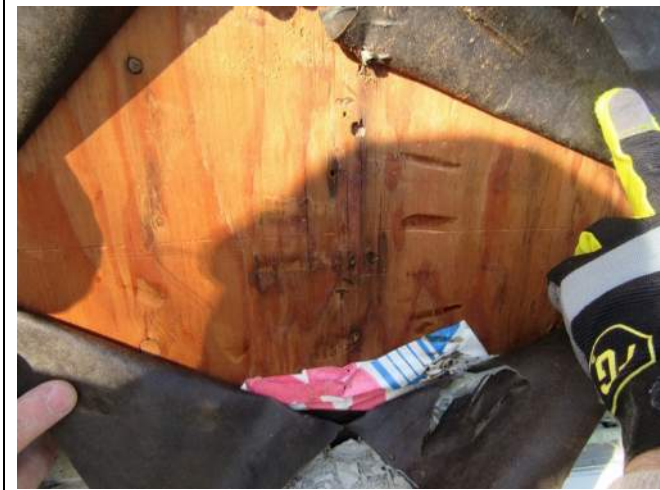
Photo No. B37.

View of exterior plywood sheathing with the asphaltic building paper peeled back.

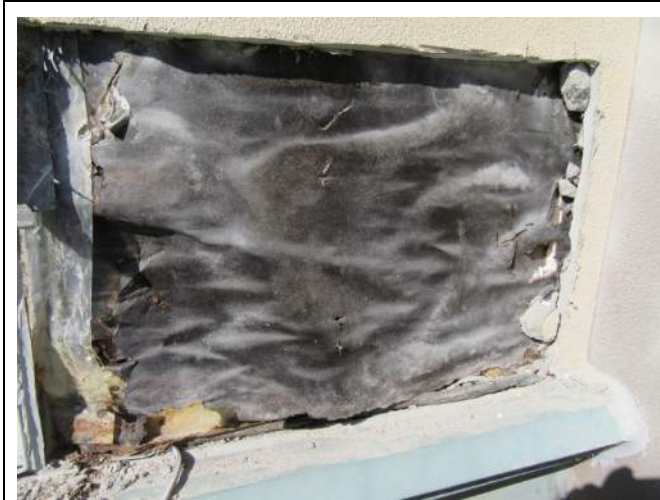
Photo No. B41.

Stucco cladding removed, showing asphaltic building paper with minor wrinkling.

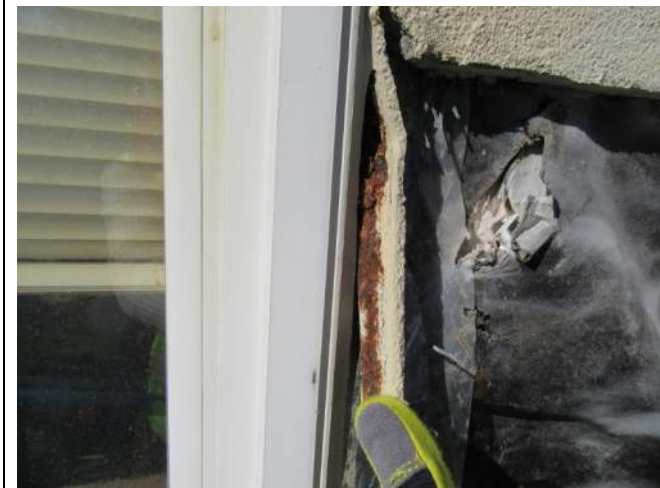
Photo No. B42.

Close-up of standing-seam that has not been properly sealed.

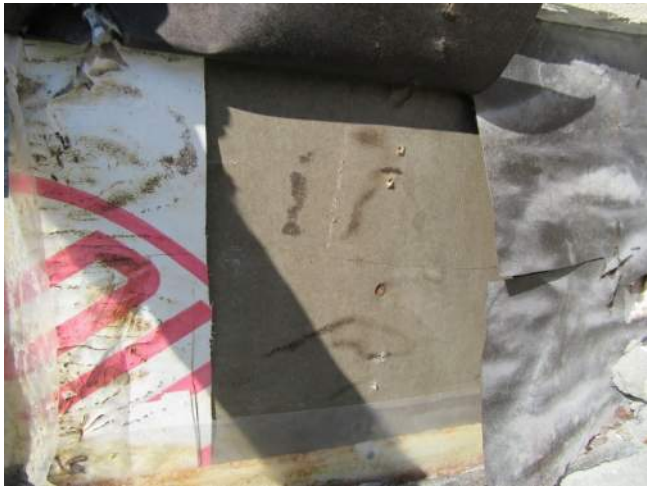
Photo No. B44.

View of exterior gypsum sheathing with the asphaltic building paper peeled back.

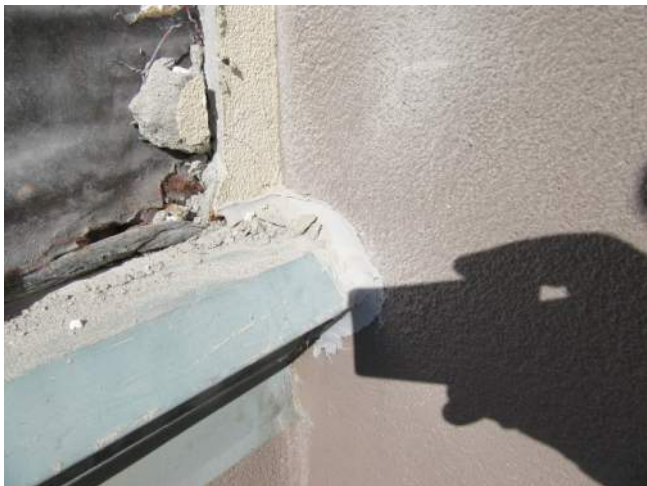
Photo No. B46.

Close-up termination of sheet metal cornice with adjacent stucco-clad wall.

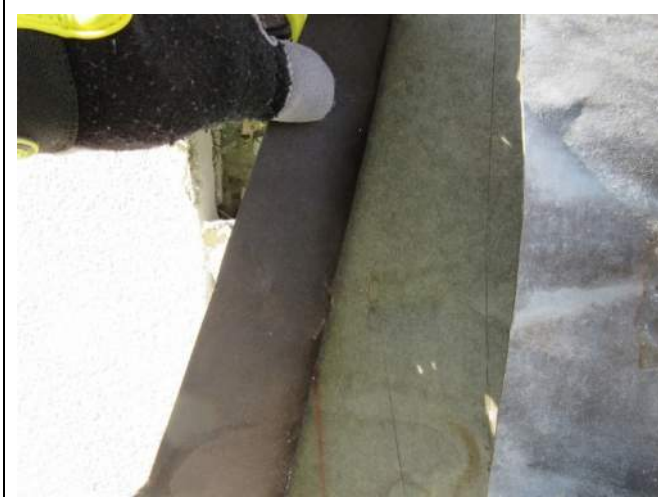
Photo No. B50.

View of exterior gypsum sheathing with the asphaltic building paper peeled back.

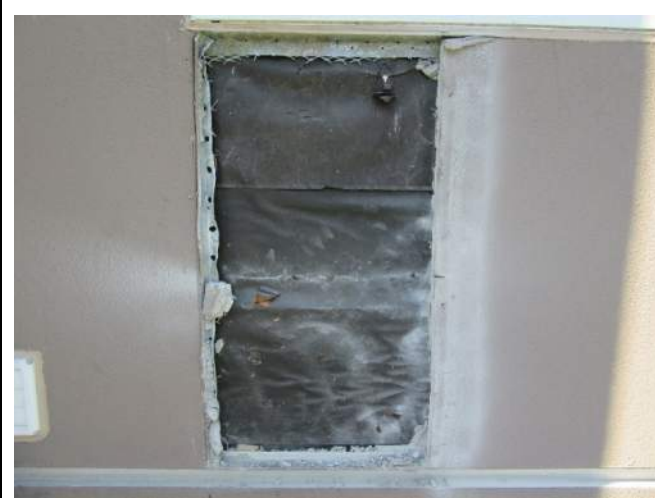
Photo No. B54.

Stucco cladding removed, showing asphaltic building paper with minor wrinkling.

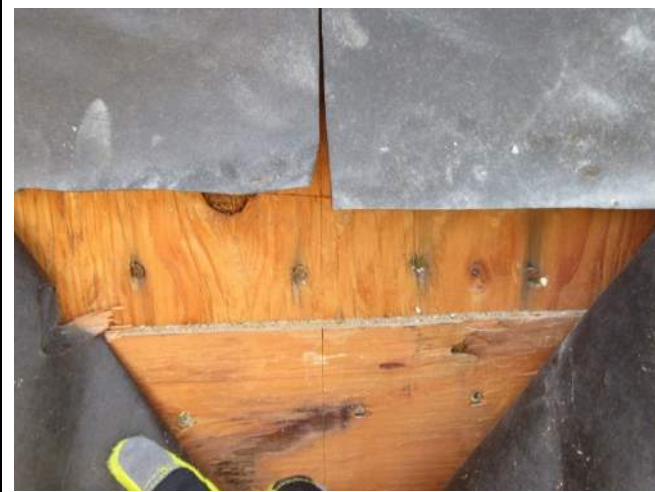
View of exterior plywood sheathing with the asphaltic building paper peeled back.

Moisture reading of 14.8% at location of dark water stain visible in Photo No. B55.

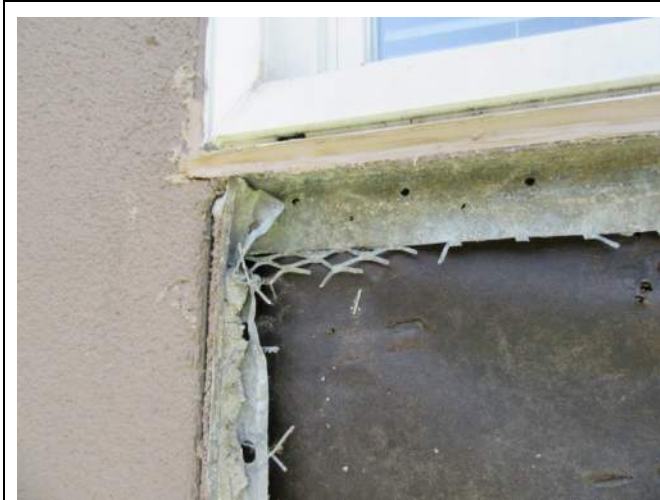
Photo No. B57.

Close-up of stucco screeds below window sill and at vertical control joint.

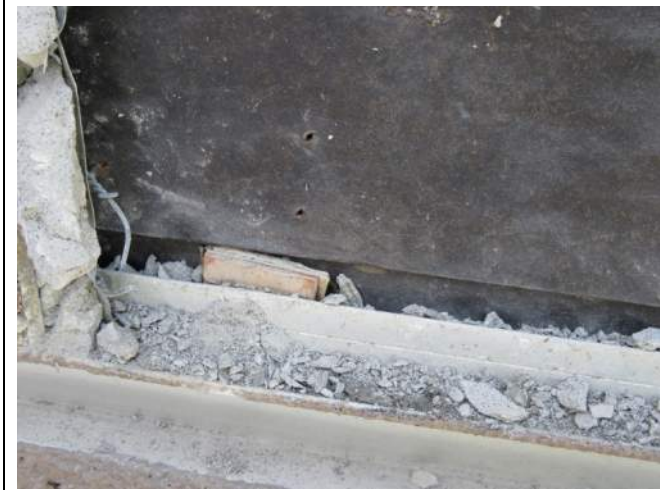
Photo No. B58.

Close-up of top horizontal flange of extruded metal reveal.
