Condition Assessment

The following photographs were taken on 10/18/21 to document the in-service conditions at the reported leak locations.

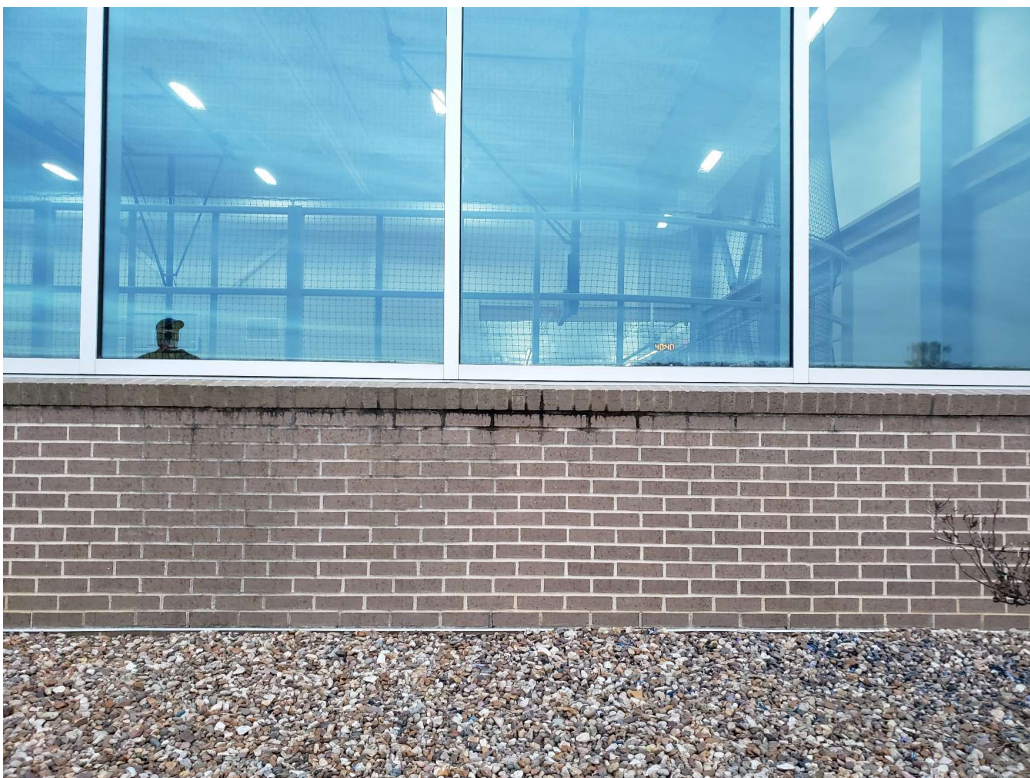
*Photo #81: View of dark residue on the mortar (north elevation, gymnasium, 10/18/21).*

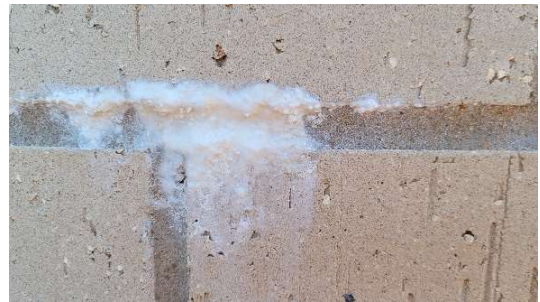
*Photo #90: Close-up view of white residue on the brick (west elevation, gymnasium, 1/11/22).*

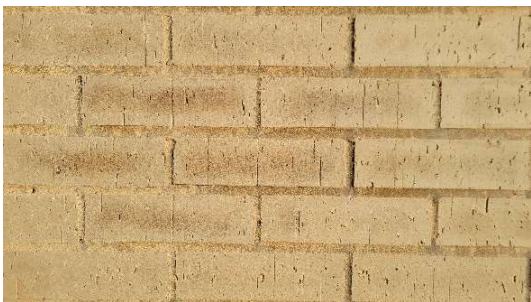
*Photo #88: Close-up view of brick discoloration (south elevation, stairwell, 1/12/22).*

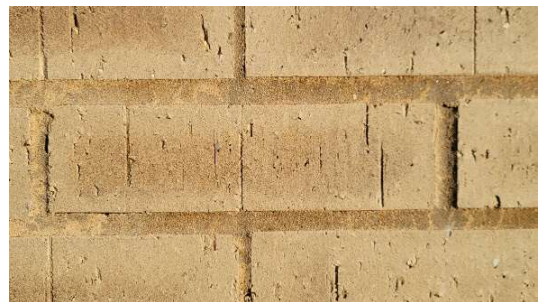
*Photo #91: Close-up view of brick discoloration (south elevation, stairwell, 1/12/22).*

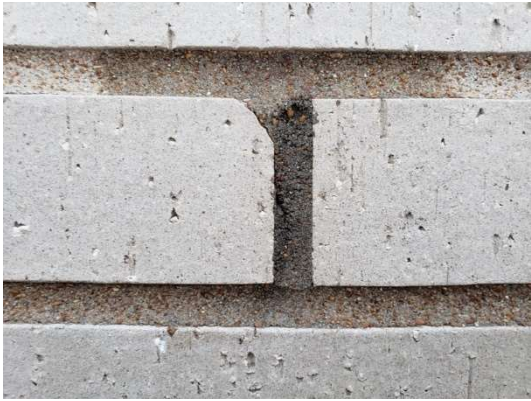
*Photo #92: Close-up view of wet mortar (north elevation, gymnasium, 1/12/22).*

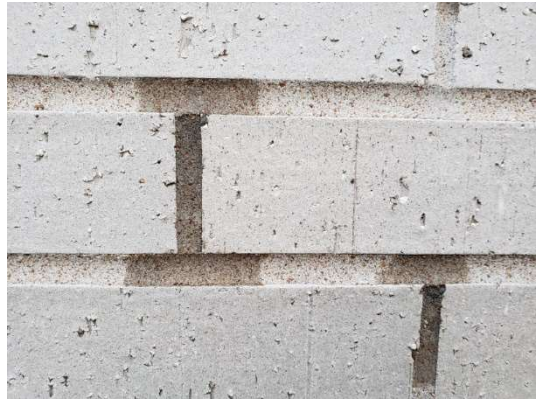
*Photo #95: Close-up view of wet mortar (north elevation, gymnasium, 1/12/22).*

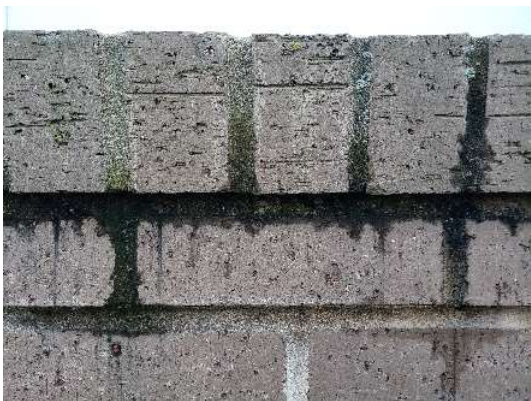
*Photo #93: Close-up view of dark residue on the mortar (north elevation, gymnasium, 1/12/22).*

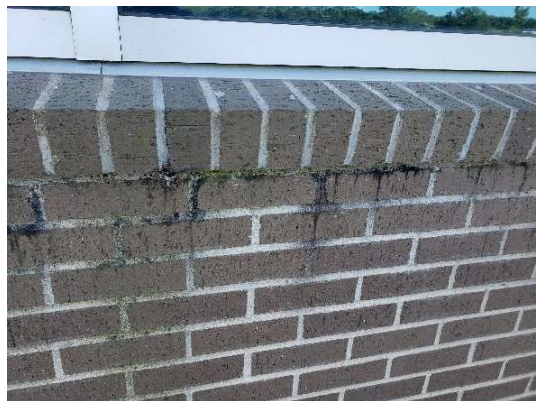
*Photo #96: Close-up view of white residue on the brick (north elevation, fitness area, 10/18/21).*

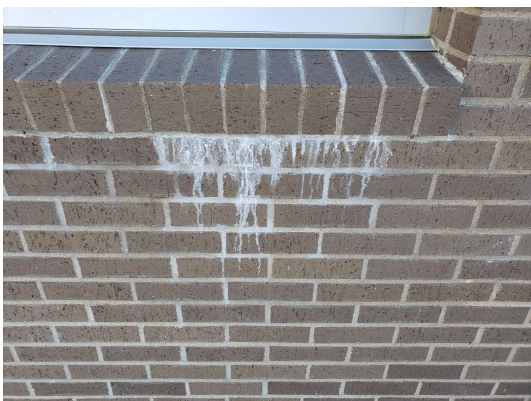
*Photo #94: Close-up view of white residue on the brick (north elevation, fitness area, 10/18/21).*

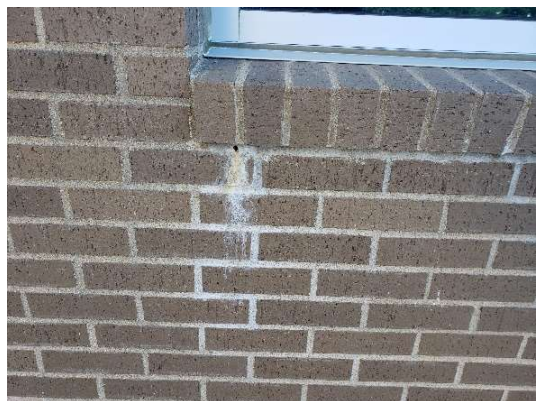
*Photo #97: Close-up view of white residue on the brick (north elevation, fitness area, 10/18/21).*
