THE ATRIUM

1079 COMMONWEALTH AVE BOSTON, MA

1 February 2024

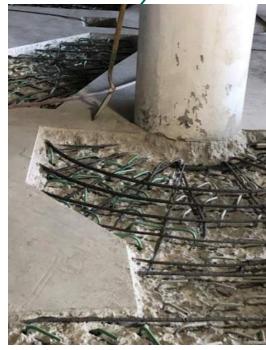
Garage Rehabilitation

- Slab Reconstruction
- Concrete Repairs
- Coating Replacement
- Plumbing Maintenance
